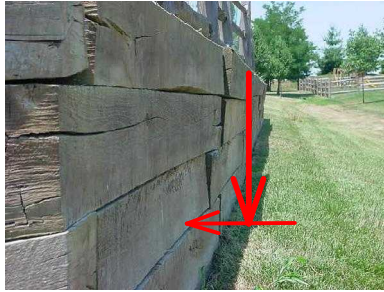
Balcony: Concrete  
 Porch: Concrete  
 Vegetation: Shrubs with some weeds  
 Retaining Walls: Railroad ties The wall is showing signs of movement, but appears to be stable at this time. A qualified contractor is recommended to evaluate and estimate repairs to maintain the wall.

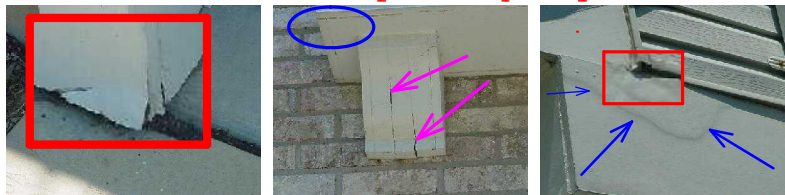
1. Water damage to trim wood at either side of garage door from moisture wicking into the finished particle board. The surface is starting to delaminate. Recommend repair/replacement of the trim boards and silicone seal wood that is in contact with concrete to prevent wicking.

2. The wood window boxes have water damage and will require repair/replacement. The wood has started to separate at the supports and at the corners of the window boxes.

3. The trim board at the southwest corner of the porch has water damage due to water penetration and will require repair/replacement of the wood. The trim board extends out creating a ledge allowing water to collect on the top edge of the board and cause the wood to rot.

Recommend estimate/repairs by a qualified contractor.

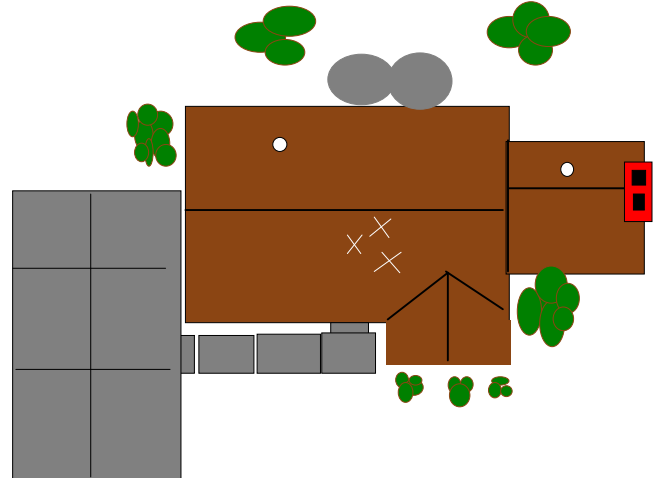
A	NP	NI	M	D	
<b>Main Roof Surface</b>						
1.	Method of Inspection: On the roof					
2.	<input type="checkbox"/>	<input type="checkbox"/>	<input checked="" type="checkbox"/>	<input type="checkbox"/>	<input type="checkbox"/>	Unable to Inspect: 30% Height of the roof
3.	<input type="checkbox"/>	<input type="checkbox"/>	<input type="checkbox"/>	<input type="checkbox"/>	<input checked="" type="checkbox"/>	Material: Fiberglass shingle <span style="color: red;">Missing roof shingles from wind damage as marked "x" in diagram. Repairs are required.</span>
4.	Type: Gable

5. Main Roof Surface Material: Fiberglass shingle Missing roof shingles from wind damage as marked "x" in diagram. Repairs are required.
6. Leader/Extension: Underground conductors Reconnect to downspout where pulling loose.

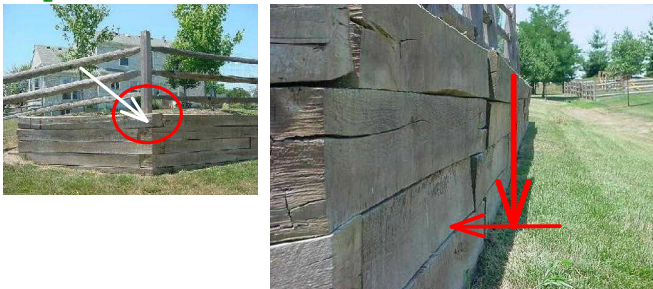
1. Vegetation: Shrubs with some weeds
2. Retaining Walls: Railroad ties The wall is showing signs of movement, but appears to be stable at this time. A qualified contractor is recommended to evaluate and estimate repairs to maintain the wall.

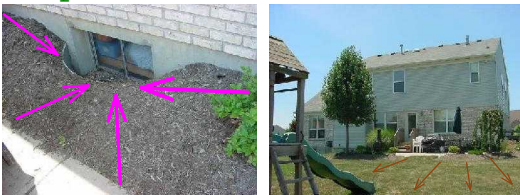
1. **Deck:** Treated wood The deck has been built below acceptable building standards and is not safe in its current state. Recommend further evaluation and estimate to bring deck up to an acceptable building standard.
2. **Grading:** Moderate slope The grade and landscaping materials are too high and extend above the window well at the Northeast rear of the home. Recommend that the grade be reduced or the metal window well soil retainer be replaced with a taller unit to keep the mulch and soil beds from washing into the well.

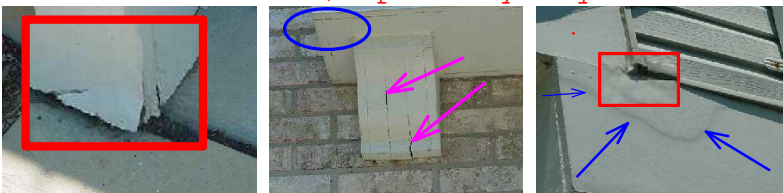
1. Water damage to trim wood at either side of garage door from moisture wicking into the finished particle board. The surface is starting to delaminate. Recommend repair/replacement of the trim boards and silicone seal wood that is in contact with concrete to prevent wicking.

2. The wood window boxes have water damage and will require repair/replacement. The wood has started to separate at the supports and at the corners of the window boxes.

3. The trim board at the southwest corner of the porch has water damage due to water penetration and will require repair/replacement of the wood. The trim board extends out creating a ledge allowing water to collect on the top edge of the board and cause the wood to rot.

Recommend estimate/repairs by a qualified contractor.
